HO-998 Knock-Frizzell-Day Farm 14347 Burntwoods Road Private

Maryland Historical Trust Maryland Inventory of Historic Properties Form

HO-998 KNOCK-FRIZZELL-DAY FARM 14347 BURNTWOODS ROAD FIRST FLOOR PLAN -- MEASURED & DRAWN BY KEN SHORT -- OCTOBER 2009

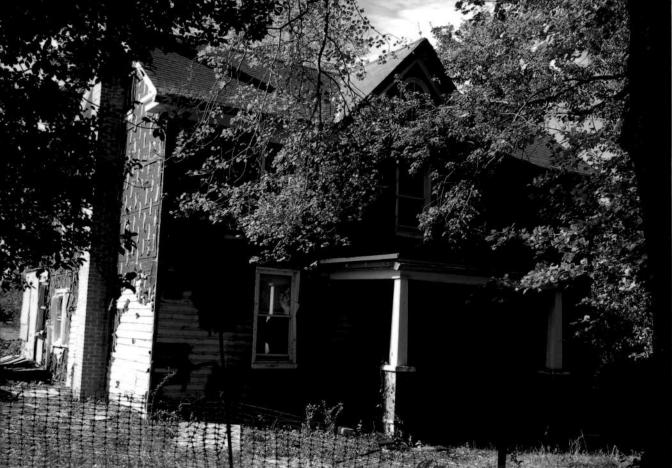
HO-998 Knock-Frizzell-Day Farm 14347 Burntwoods Road Howard County IND Ken Short Oct. 20, 2009 MD SHPO North Elevation

The north elevation siding has wire nails. The first story has a center entrance that is boarded over and has all new one-over-one double-hung sash, with the frames and the sills covered with aluminum. There is a one-story, one-bay porch in the center that has a flat roof, a concrete deck with brick edging, two brick piers with battered posts, and a plywood soffit. There is a ghost beneath the tar paper covering the German siding of a three-bay, one-story porch that previously existed. The second story has three one-over-one sash and there is a cross gable in the center with a semi-circular-arched two-over-two sash. The box cornice with returns is covered with aluminum.

HO-0998_2009-10-20_01 North elevation

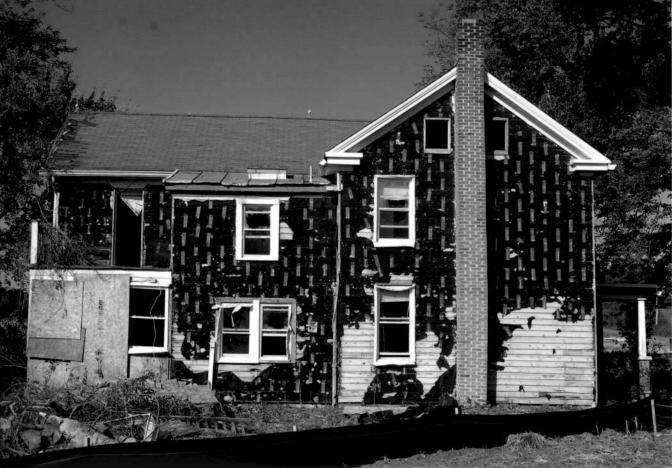
HO-998 Krock-Frizzell-Day Farm 14347 Burntwoods Roock Howard County, MD Ken Short Oct. 20, 2009 MD SHPO East Ekvation

The east elevation of the main block has a new brick chimney in the center on the exterior and a one-over-one sash in the south bay of both the first and second stories. There is no opening in the north bay of either story. The gable end has two small window openings. The east elevation of the east addition has a pair of one-over-one sash on the first story and a single one-over-one sash on the second story. The east elevation of the ell, on the second-story south bay, has a doorway with a new 15-light door.

HO-0998_2009-10-20_02 East elevation

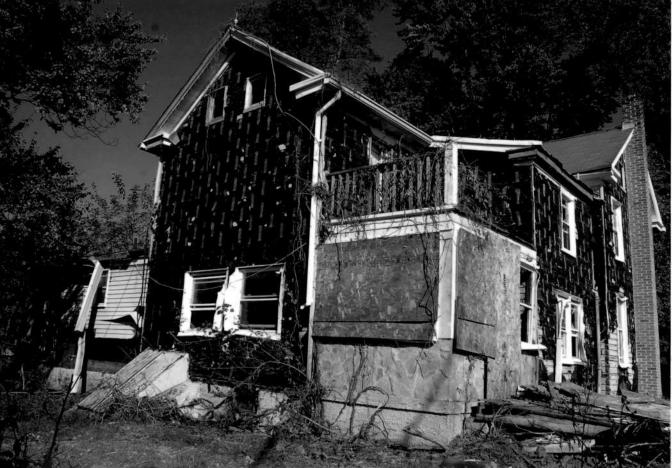
HO-998 Knock-Frizzell-Day Farm 14347 Burntwoods Read Howard County MD Ken Short Oct. 20, 2009 MD SHPO South & East Elevations

The south elevation of the ell has a cellar bulk-head door to the west and a small window opening to the east. The first story has two wide one-over-one sash and the second story has no openings. The gable end has two small window openings. The ell also has a wood box cornice with returns, all of which is covered with aluminum.

HO-0998_2009-10-20_03 South & east elevations

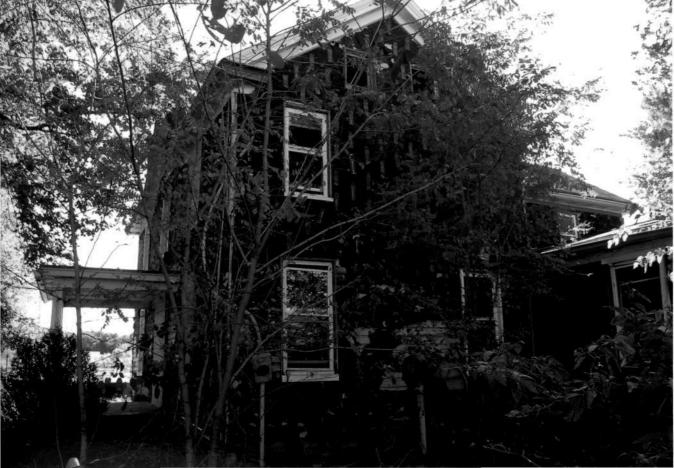
HO-998 Knock-Frizzell-Day Farm 14347 Burntwoods Road Howard County, MD Ken Short Oct. 20, 2009 MD SHPO West Elevation, North end

The west addition covers the first story of the ell and the main block. The west elevation of the ell, on the second story, has two one-over-one sash. The west elevation of the main block has two one-over-one sash on the first story and a single one-over-one sash in the north bay of the second story. The gable end has two small window openings, one with the remains of a four-light sash, and there is another four-light sash on the ground in this location. The sash is mortise and tenon and pinned at the corners and at the ends of the vertical muntin. The pins do not pass all the way through the frame of the sash, but are only visible on one side. The ovolo mouldings on the sash are run on the stiles, and the rails are coped around them rather than cutting them off. The joints are not wedged.

HO-0998_2009-10-20_04 West elevation, north end

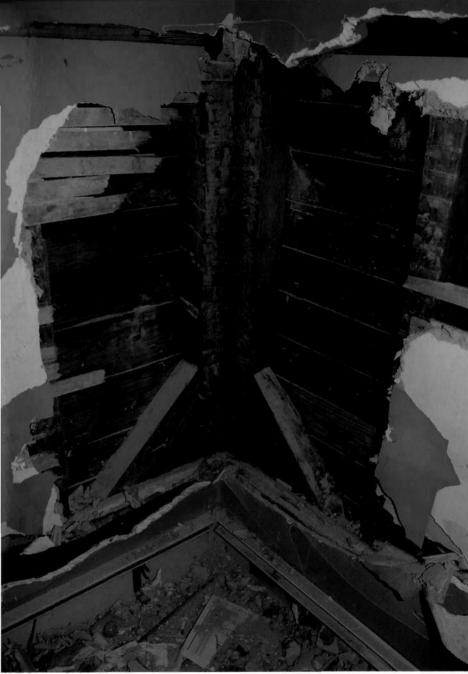
Knock-Frizzell-Day Farm 14347 Burntwoods Road Howard County, HD Ken Short Oct. 20, 2009 MD SHPO Northeast room, Framing in Northeast

The east and west rooms were both furred out and dry-walled. The northeast corner was opened up on the first story, revealing a hewn, guttered corner post that is 4 inches deep in each wall and has a 3 ½-inch exposed face on both sides of the guttering. There are sash-sawn down-braces that are 3 inches by 4 ¾ inches, and have a halved-tenon into a center mortise in the corner post, with a peg. The joints of the down-braces are aligned, not off-set. The studs are sash-sawn, are 2 ¾-inches by 4 inches, and are spaced 20 to 21 inches on centers. The current cut lath nails are the only nails that were ever in these studs, and they fasten circular-sawn lath. The plaster has several coats of white wash, then wall paper, and was finally painted a medium green before being covered with batts of rock-wool insulation and dry wall.

HO-0998_2009-10-20_05 Northeast room, framing in northeast corner

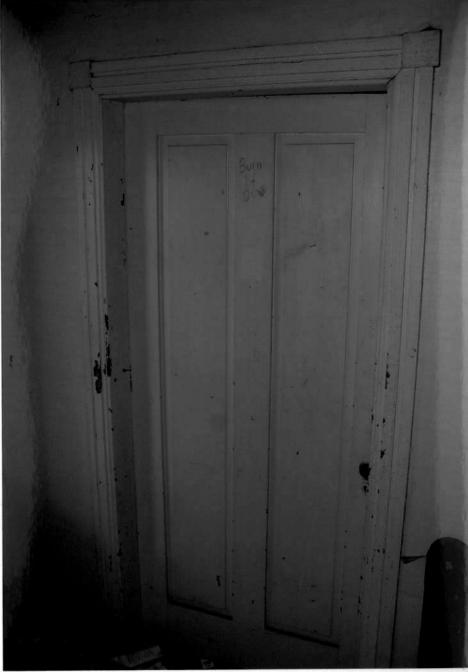
40-998 Knock-Frizzell-Day Farm 14347 Burntwoods Road Howard County, MD Ken Short Oct. 20, 2009 MD SHPO Second Story east chamber door

The east chamber west door has the same architrave as on the passage side, but the windows have mitered architrave with a beaded interior edge. The south door that leads to the cross-passage has two panels and dates to the circa 1920s. It has plain mitered architrave, and the door has a small mortise lock with brass knobs. There is carpeting on the floor and plain baseboard.

HO-0998_2009-10-20_06 Second story east chamber door
